**WORLD WAR II GERMAN  
FIRE DOCUMENT TRANSLATIONS**

## **WORLD WAR II GERMAN FIRE DOCUMENT TRANSLATIONS**

By: Carl F. Miller

REPORT OF THE REGIMENTAL COMMANDER OF THE FIRE-PROTECTION POLICE REGIMENT "SAXONY" ABOUT THE COURSE AND RESULTS OF THE MASSIVE AERIAL ATTACKS ON ROTTERDAM ON MAY 14, 1940, AND THE EXPERIENCES DRAWN THEREFROM (by Hans Rumpf) . . . . .	A-1
The Air Defense Fire Service . . . . .	A-1
The German Action to Occupy Rotterdam and the Aerial Attack of May 14 . . . . .	A-2
The Consequences . . . . .	A-3
The Organization of the Rotterdam Fire Department . . . . .	A-12
Efforts of the Voluntary Fire Department of Rotterdam After the Great Aerial Attack of May 14 . . . . .	A-21
Losses of the Rotterdam Fire Department . . . . .	A-24
Eyewitness Accounts . . . . .	A-25
Comments on the Foregoing Eyewitness Accounts . . . . .	A-40
The Renewed Superiority of Effects of Fire . . . . .	A-44
Additional Observations . . . . .	A-55
Appendix (to Rumpf's Report) . . . . .	A-71

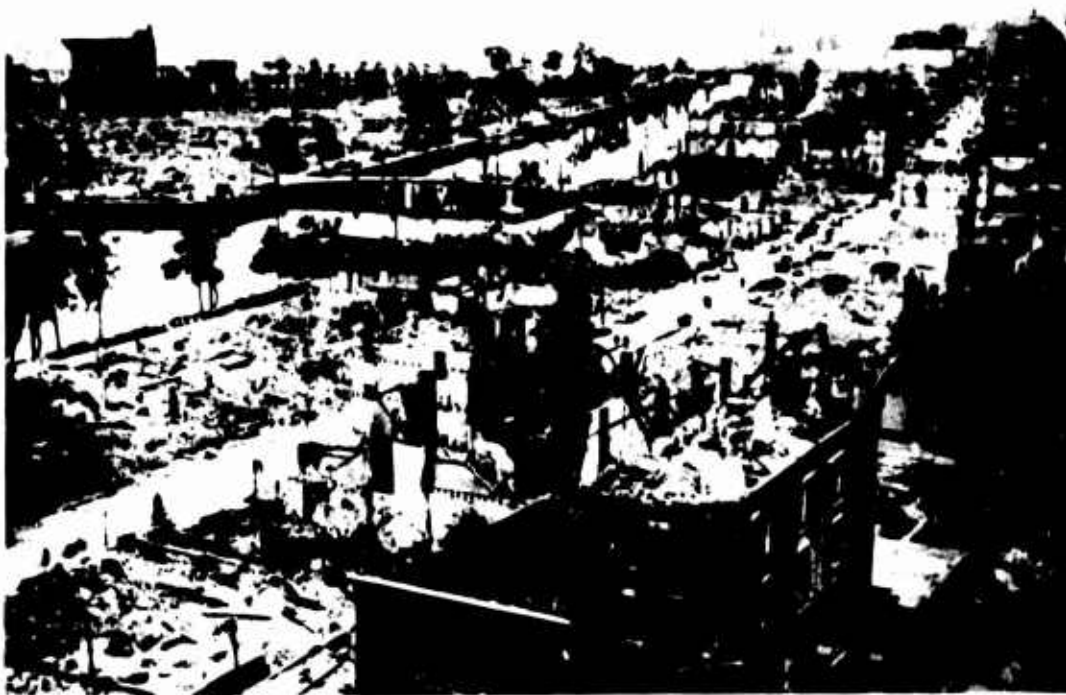
**Picture 7 THE OTHER SIDE OF THE MAAS RIVER, AN ISLAND WHICH WAS FIRST OCCUPIED BY OUR PARATROOPERS**

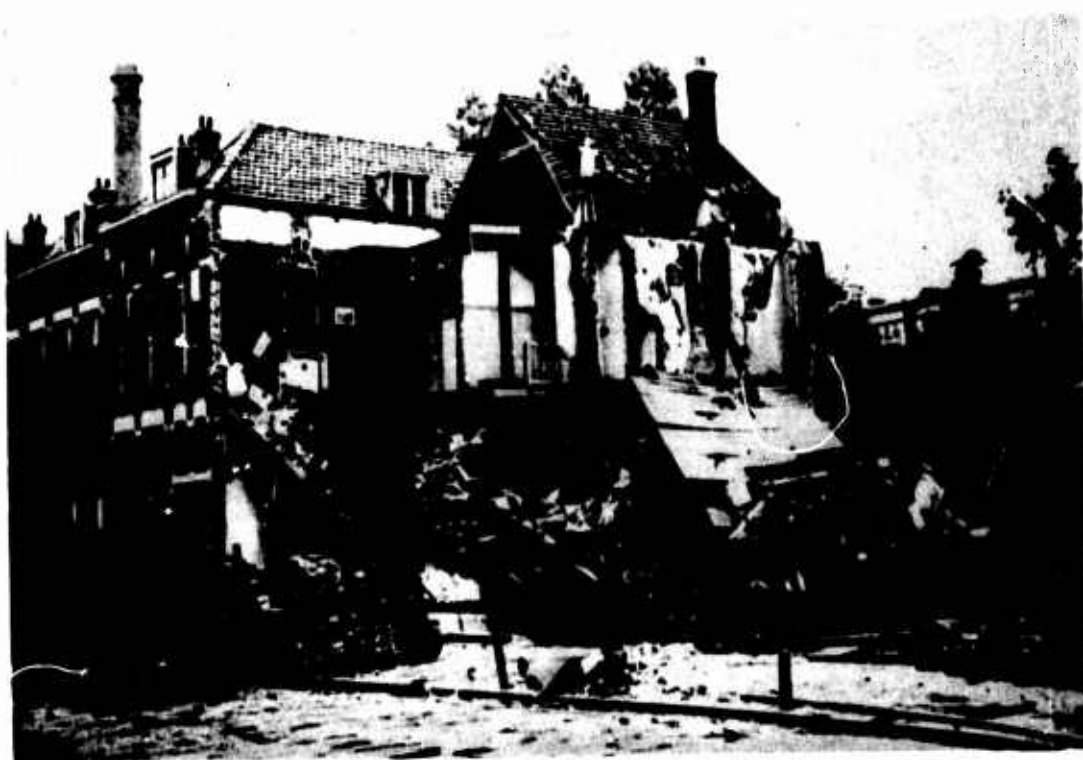
**Pictures 29, 30 BOMB HITS ON BUSINESS BUILDINGS THAT CAUSED PARTIAL DESTRUCTION  
BUT DID NOT DESTROY THE BUILDING COMPLETELY**

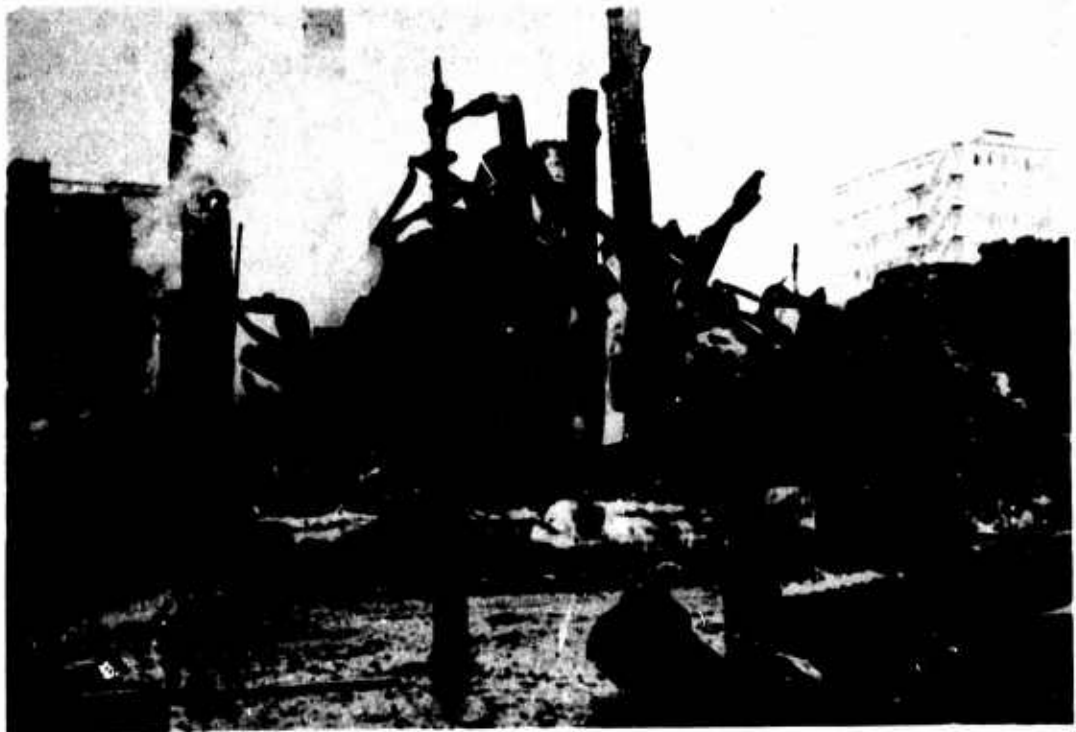
A characteristic of fire ruins is the tangle of twisted metal. With the exception of a few buildings which received a direct hit by a high explosive bomb and were left standing without burning (see Pictures 25 to 30), all parts of the field of ruins show the typical destruction by fire, with the metal supports twisted by heat and fire (see Pictures 33 to 42).

**Pictures 35, 36** TWISTED STRUCTURAL STEEL, CHARACTERISTIC OF STRUCTURES  
DESTROYED BY FIRE

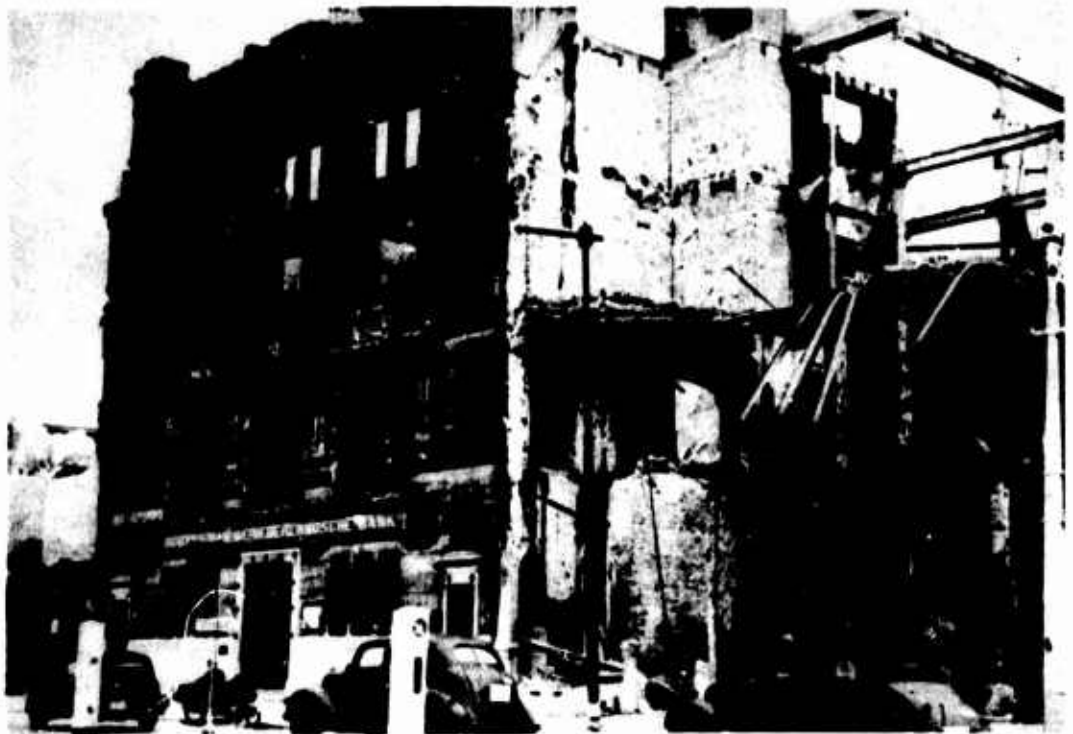
**Pictures 41, 42 TWISTED STRUCTURAL STEEL, CHARACTERISTIC OF STRUCTURES DESTROYED BY FIRE**

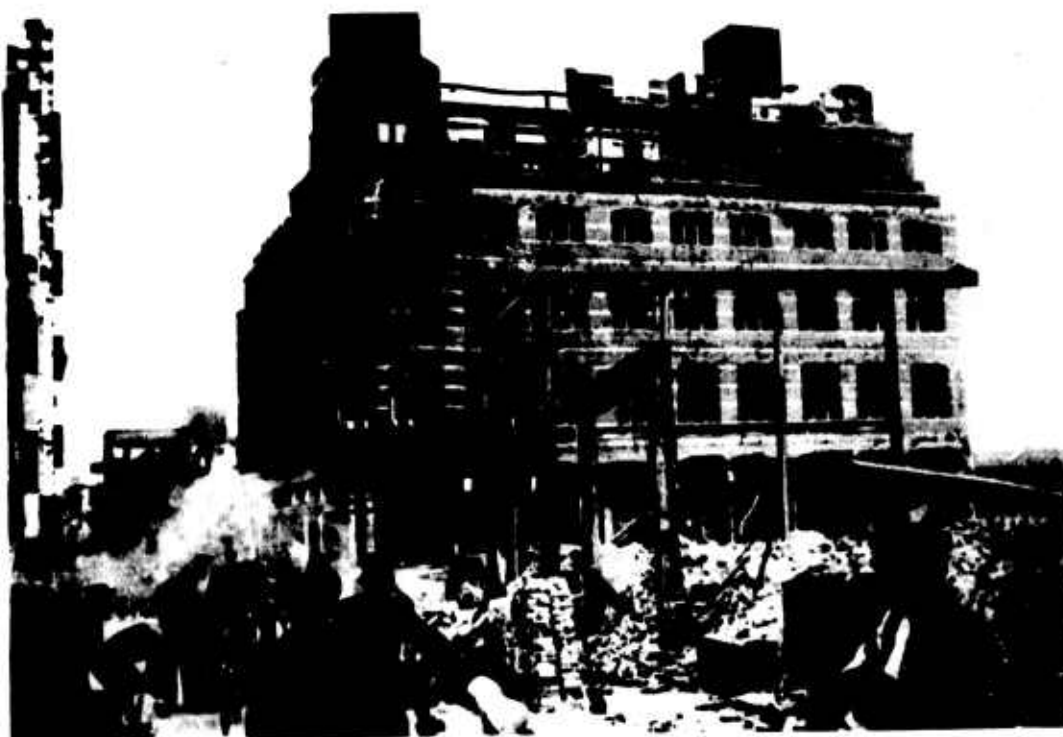
Also, from the outside the countless blackened facades of remaining buildings show plainly that the destruction was accomplished by fire and not through the force of high explosive bombs (Pictures 43 to 55).

Pictures 50, 51 SOOT-BLACKENED STRUCTURES

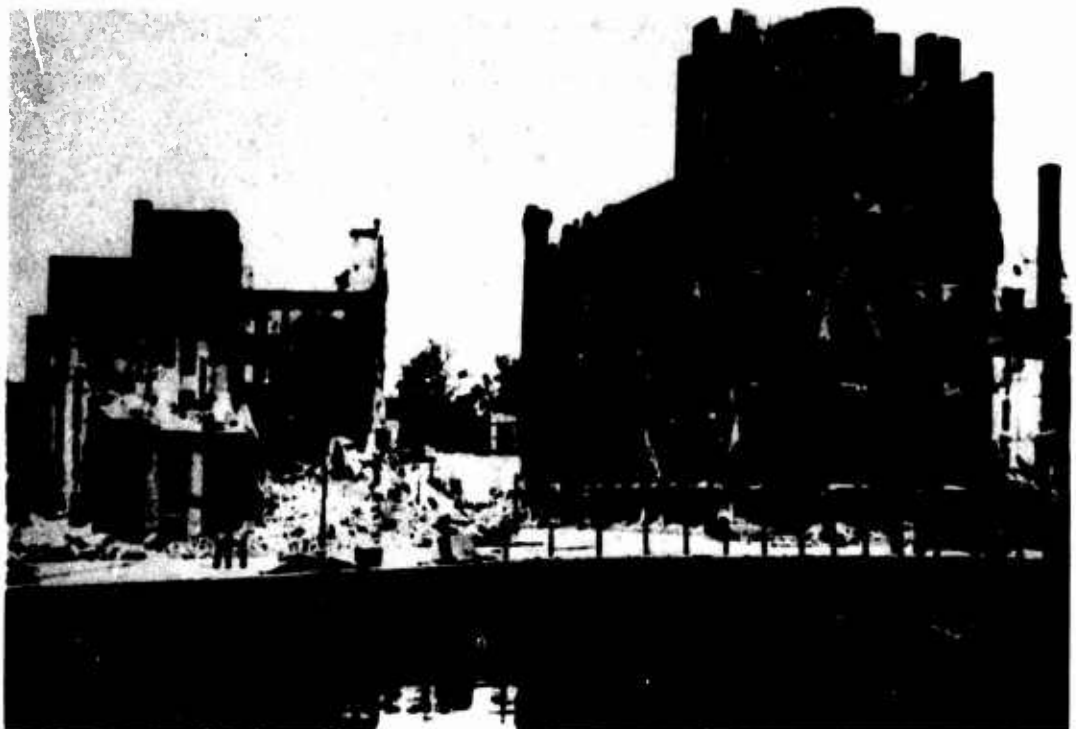
Pictures 52, 33 SOOT-BLACKENED STRUCTURES

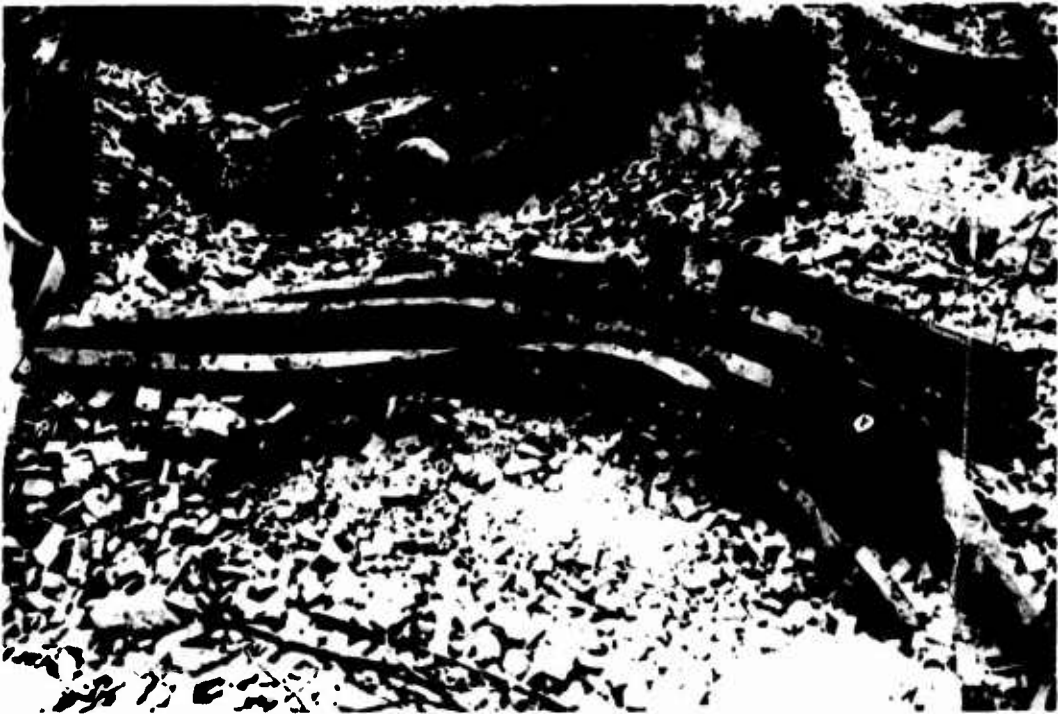
The temperatures occurring in a citywide fire are much higher than the ones observed in single fires, even those of large dimensions. That copper, brass, and glass melted was not surprising. We even found melted beams, a phenomenon which points to decidedly higher temperatures (see Pictures 59 and 60). Brick buildings show fire damage from heat effects that usually result from heat and water combined (see Picture 61). The only things that successfully withstood the enormous temperatures were the steel safes built into the walls of banks (see Pictures 62 and 63).

Pictures 59,60 MELTED AND TWISTED BEAMS

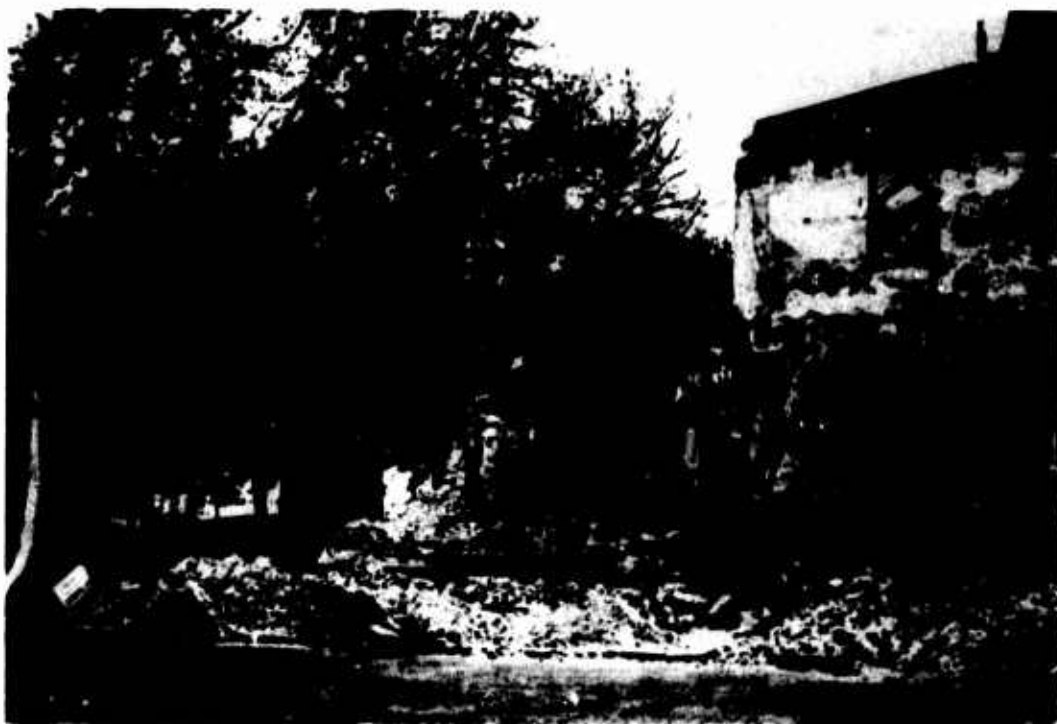
Stands of trees surprisingly often brought the fire to a halt. In many cases, houses or groups of houses situated behind rows of trees or surrounded by trees remained undamaged. It therefore seems that the existence of a great number of trees in a city will have to be taken into consideration when estimating the vulnerability to fires after air attacks (see Pictures 64 to 66).

**Picture 64 TREE FIREBREAK**

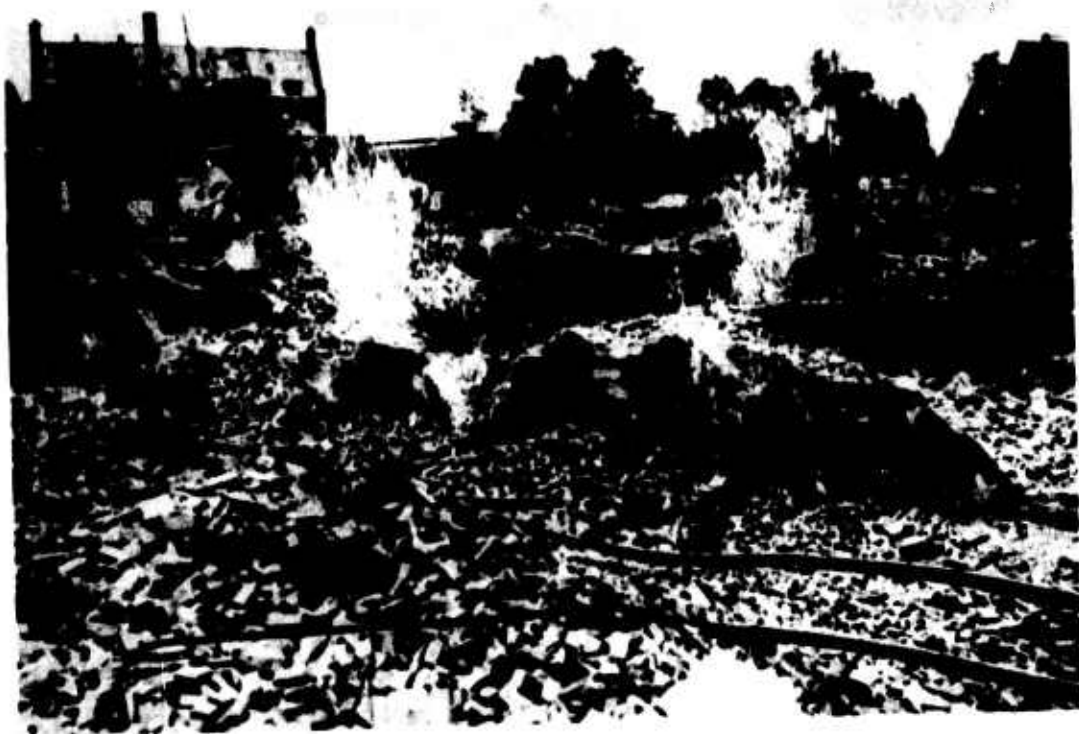
Pictures 65,66 TREE FIREBREAKS

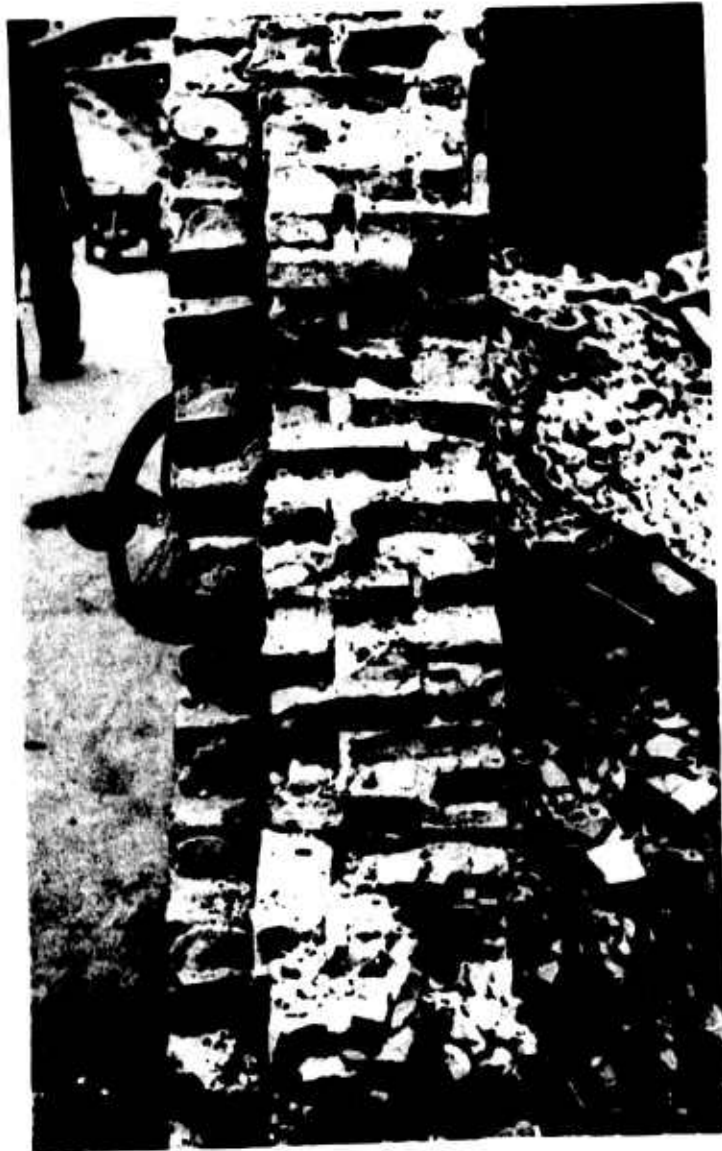
You can see in Picture 75--as hard as this may be to understand for a German--two outer walls of two neighboring buildings, where the left one has the thickness of only 0.5 stone or 8.5 centimeters.

**Picture 75 ILLUSTRATION OF DUTCH BRICK WALL CONSTRUCTION**

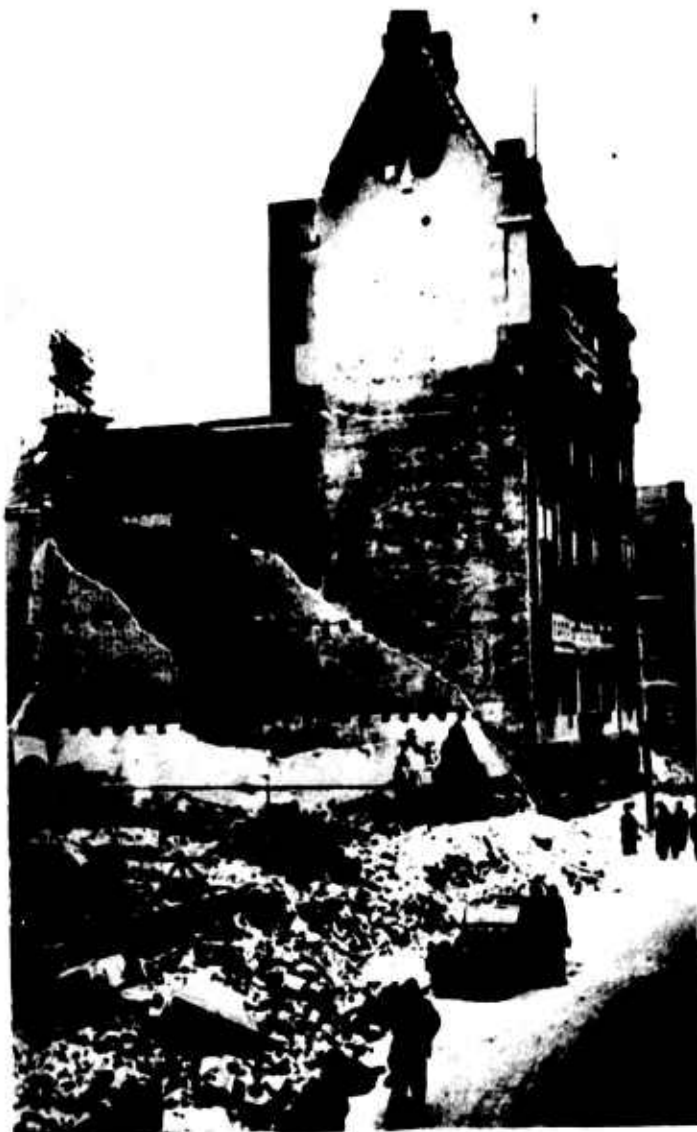
In contrast to the above-mentioned buildings made from Dutch brick, the buildings made from German brick stood up well in the fire and even survived better than concrete buildings. Picture 78 shows a warehouse and Picture 79 a department store (Brennigmeier). Both were gutted completely and all fixtures and merchandise burned. The German brick survived without crumbling and without sintering, thereby preventing collapse of the walls. In Picture 80, to the right, a Dutch clinker building can be seen with the hollow stone ceilings collapsed but with the outer walls left standing. On the left is the collapsed office building of the Rotterdam telephone company, built of Dutch brick. Pictures 81 and 82 plainly show the destruction as related to building methods and materials. In the foreground are totally destroyed residences and business buildings built of Dutch brick. The church in the background in Picture 81 and the office building in Picture 82 are built with brick and brick and sandstone, respectively.

**Picture 82 RELATIVE FIRE-RESISTANCE OF DUTCH AND  
GERMAN BRICK WALL CONSTRUCTION**
